ENEWETAK FACT BOOK

(A RESUMÉ OF PRE-CLEANUP INFORMATION)

COMPILED BY
WAYNE BLISS
U.S. ENVIRONMENTAL PROTECTION AGENCY

COMPILED 1977
PUBLISHED SEPTEMBER 1982

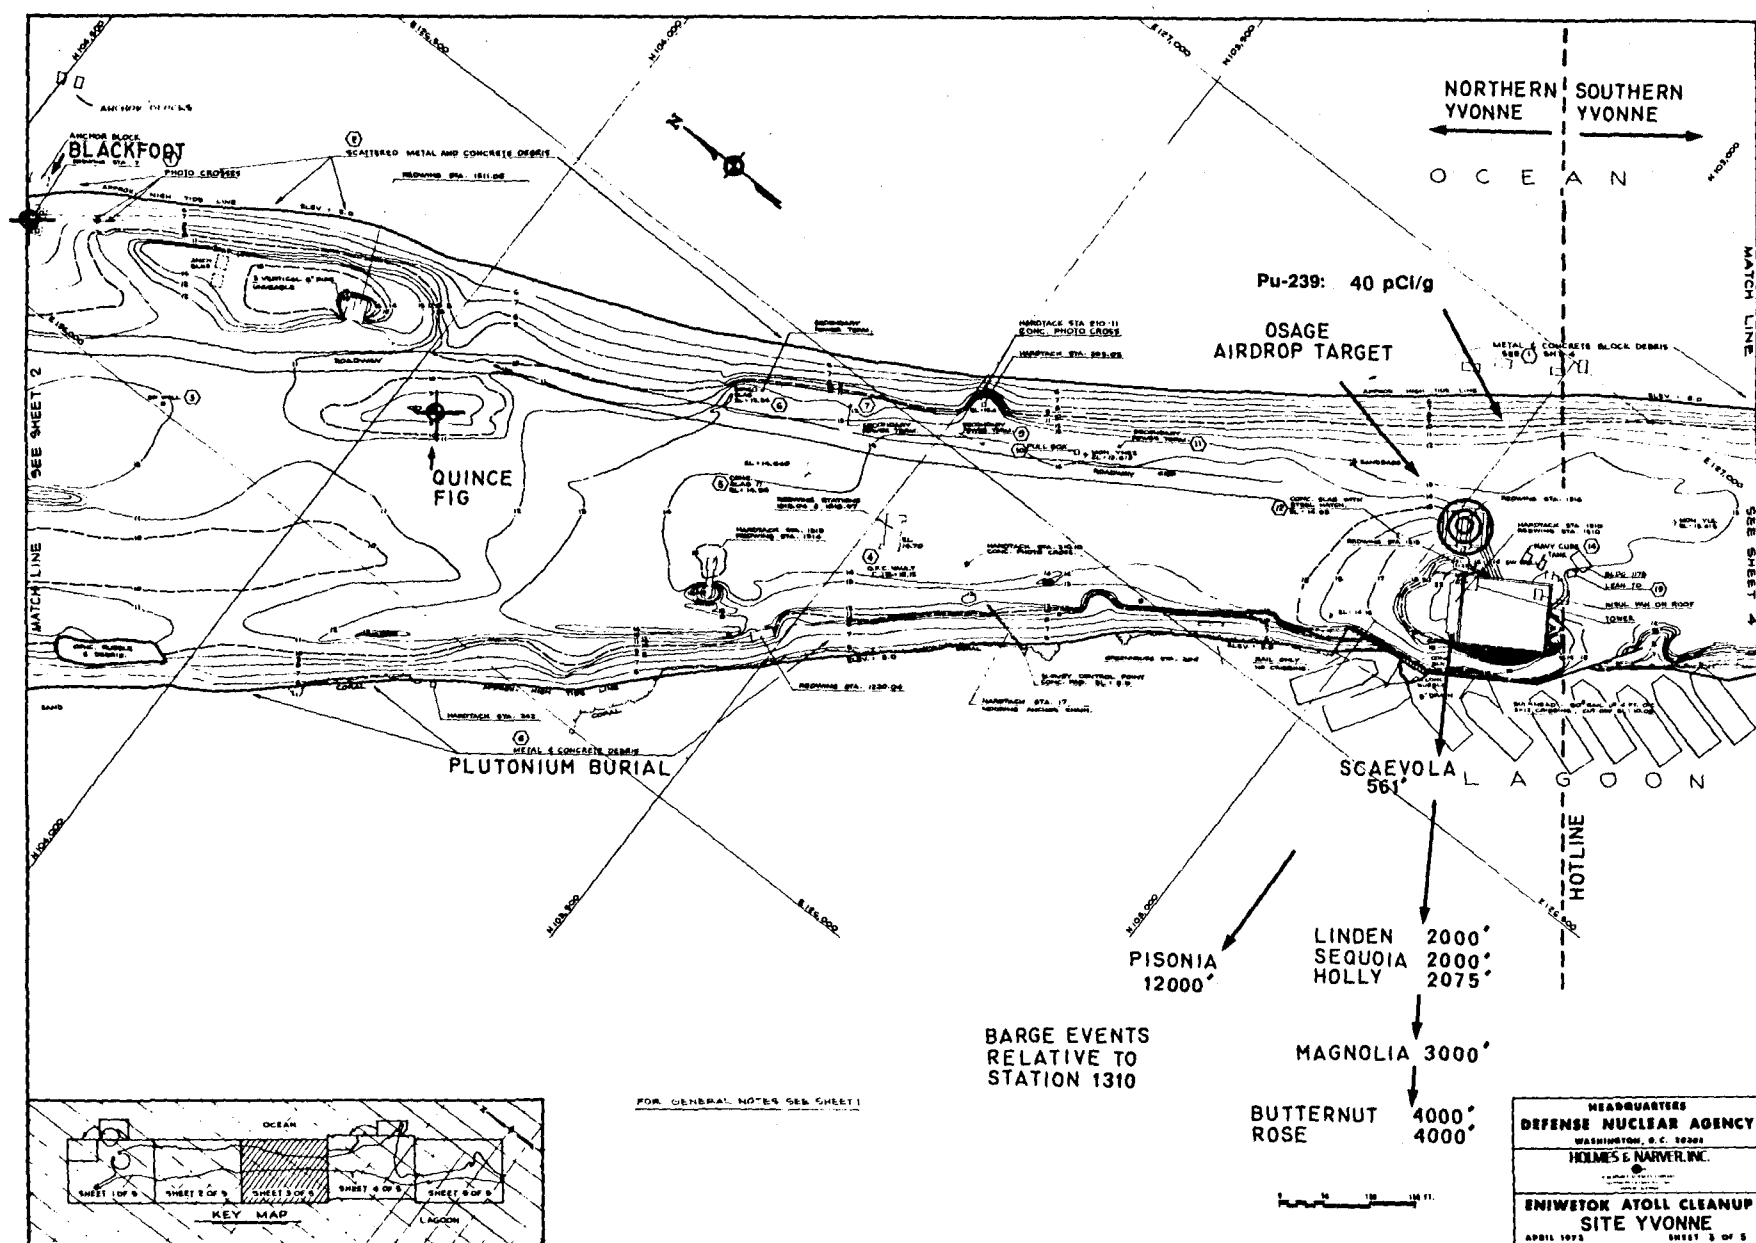
FIGURE 65. SITE YVONNE, SHEET 3 OF 5, SOUTH END

SOUTHERN YVONNE was the location of one nuclear experiment, ERIE, detonated May 30, 1956, on a 300-foot tower north of the aircraft runway. The OSAGE event of June 16, 1956, was airdropped and detonated approximately 670 feet over Station 1310 (Figure 65). Seven barge events were conducted in the lagoon near YVONNE and five surface shots were executed on NORTHERN YVONNE.

A jar containing sand contaminated with high activity plutonium may be found buried at the left side of the south entrance to Station 1310.

A small (15 x 15-ft) fenced area immediately north of the approach end of the runway may be found to contain a box which contains some contaminated material. This material includes activated metal, contaminated sand in a jar, a small disk with high alpha activity and a small disk with an exposure rate of 100 mR/h. A large portion of the scrap metal and debris between Station 1310 and the runway is contaminated. The highest exposure rate (60 mR/h) reported in NVO-140 is for the pile of rubble on the reef north of the runway and the ERIE GZ.

Early cleanup operations to occur on SOUTHERN YVONNE should be initiated carefully and with the knowledge that 40 pCi/g plutonium levels exist in soil near the east end of the proposed hotline, in the ERIE GZ area, and that any debris, surface or unearthed, may present a radiological hazard.

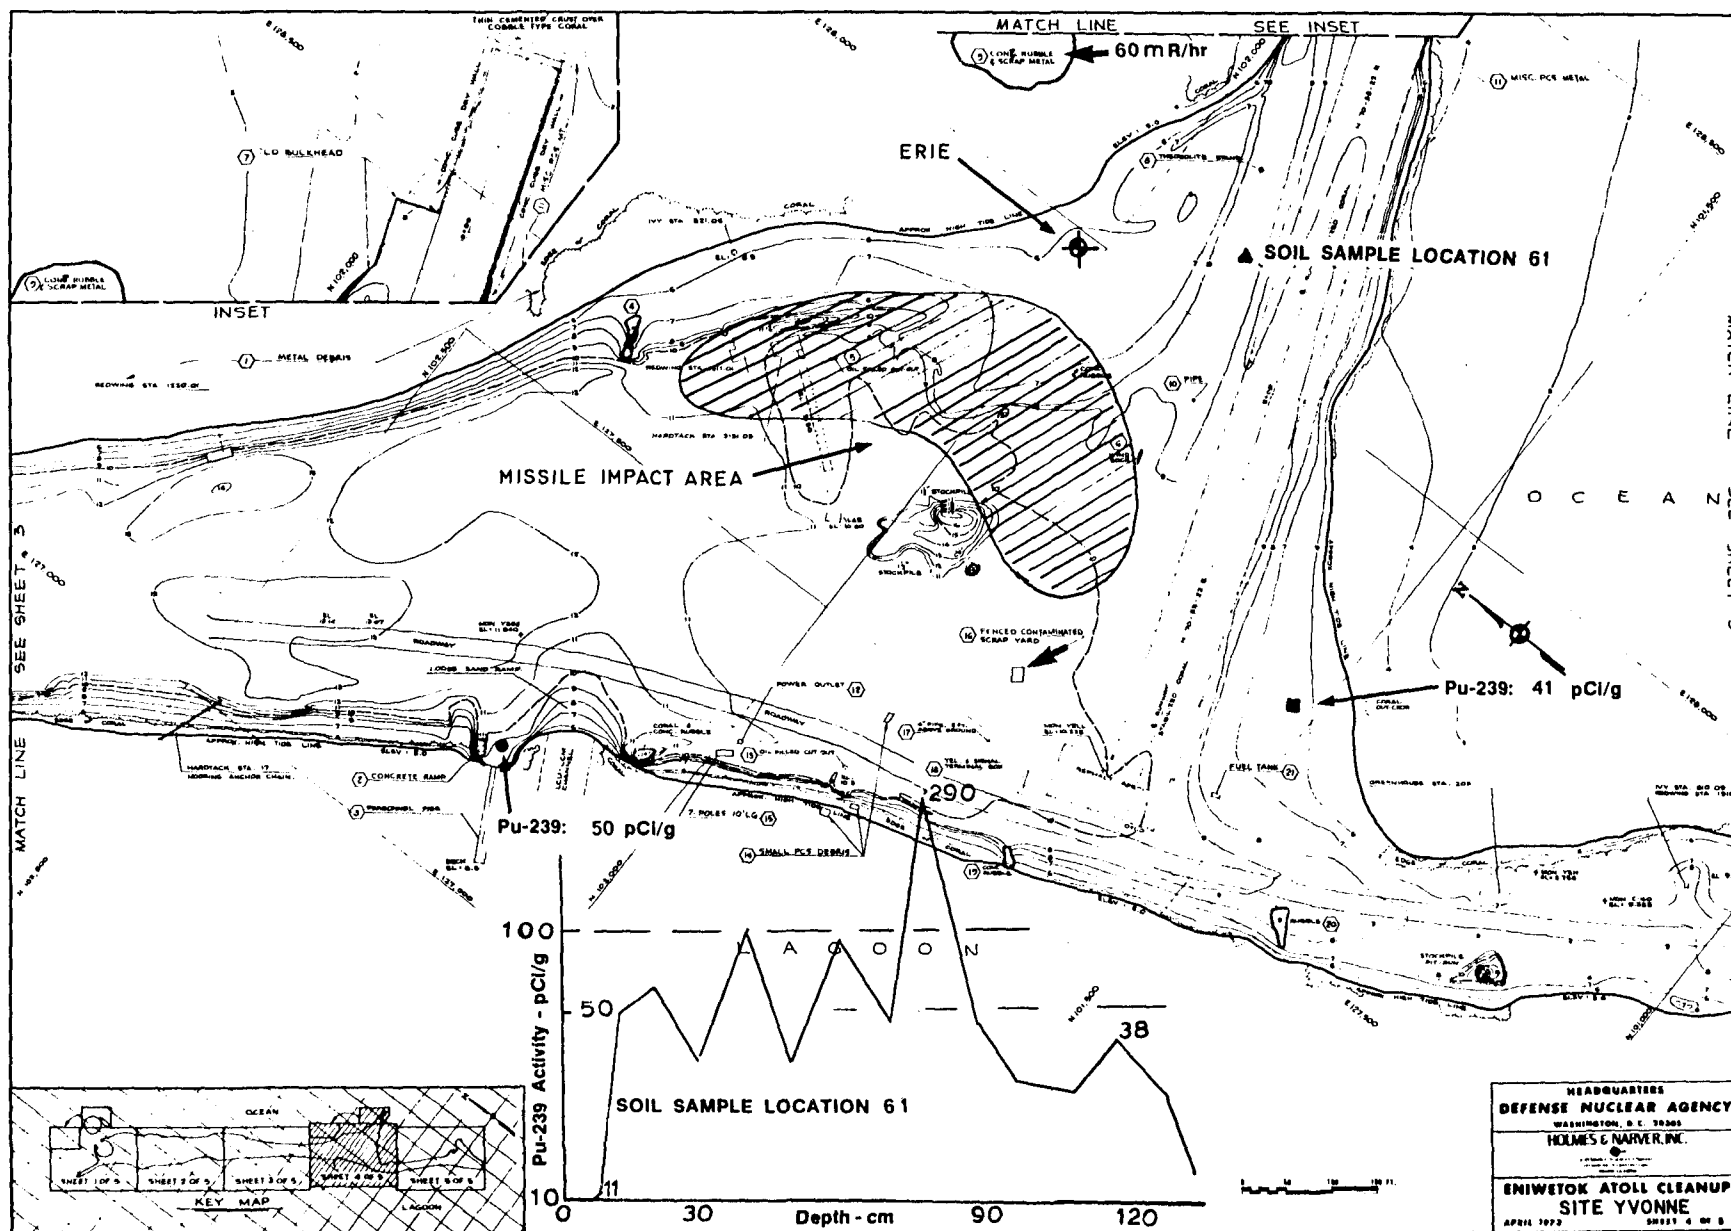
FIGURE 66. SITE YVONNE, SHEET 4 OF 5

The ERIE device produced heavy contamination on YVONNE. The behavior of the device was such that much debris remained in the GZ area. Also ERIE was heavily instrumented to evaluate weapons effects on missile structures and materials. Six arrays of test specimens were arranged west of the air zero at 45 degrees from horizontal and below air zero such that the specimens would impact west of ground zero. Specimens were recovered as far as 450 feet from ground zero and generally from northwest through southwest and at depths of up to five feet. It is reported that earth was excavated up to six to eight feet deep and that 100,000 cubic yards of earth was moved in the recovery operations. Not all specimens were recovered; however, should any be found during cleanup, no significant radiological hazard would be expected. The recovery procedure involved making 6-inch cuts with a "carry-all" and spreading the earth in 2-inch layers. The earth was removed from the impact area and spread in a pattern about 300 feet long and three swaths wide (about 24 feet) northwest of GZ. The soil was piled along the ocean side of the island. The pile was later returned to the impact area and the area graded (1957). The exact boundaries of the excavation are unknown and core sampling may be necessary to fix its location. The missile impact area is noted on Figure 66.

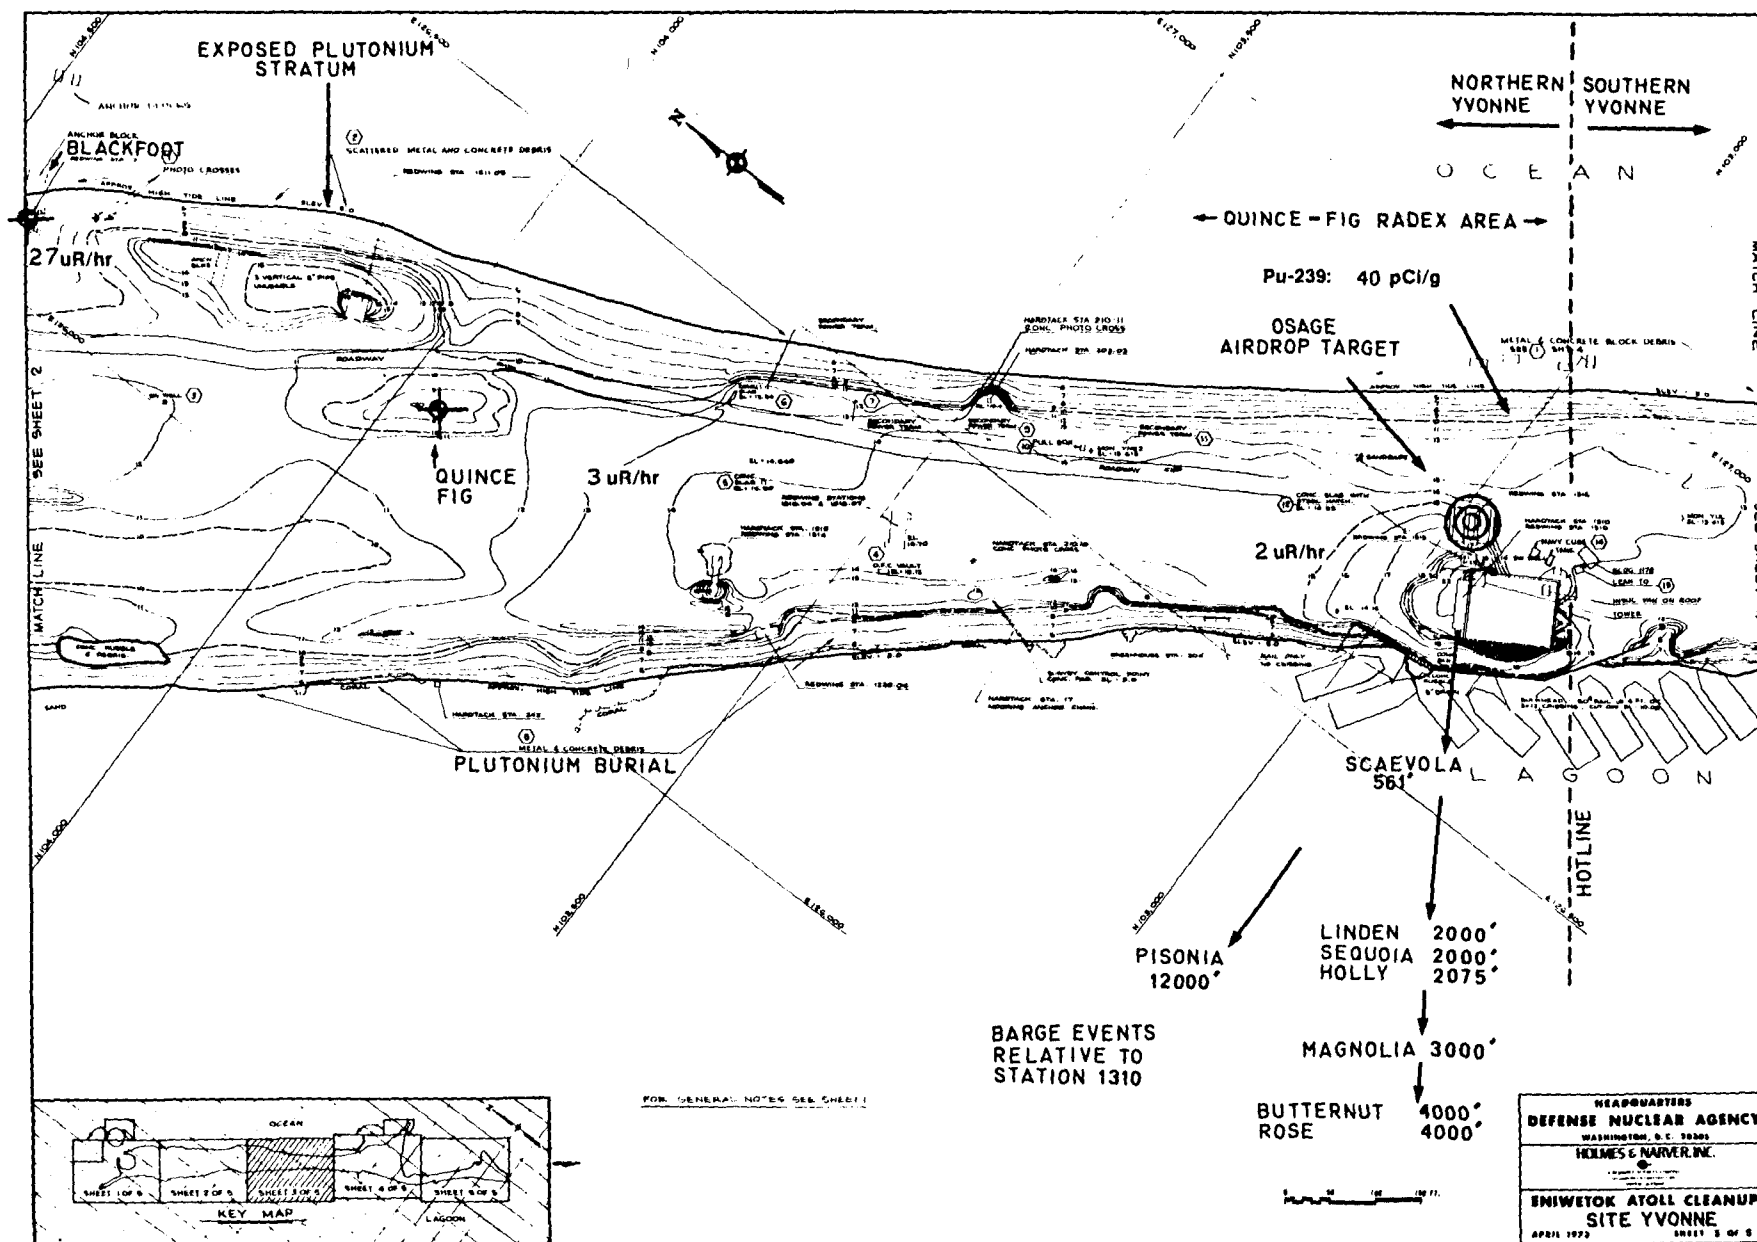
FIGURE 70. SITE YVONNE, SHEET 3 OF 5, NORTH END

Seven additional barge shots were conducted in the lagoon near YVONNE as shown on Figure 70.

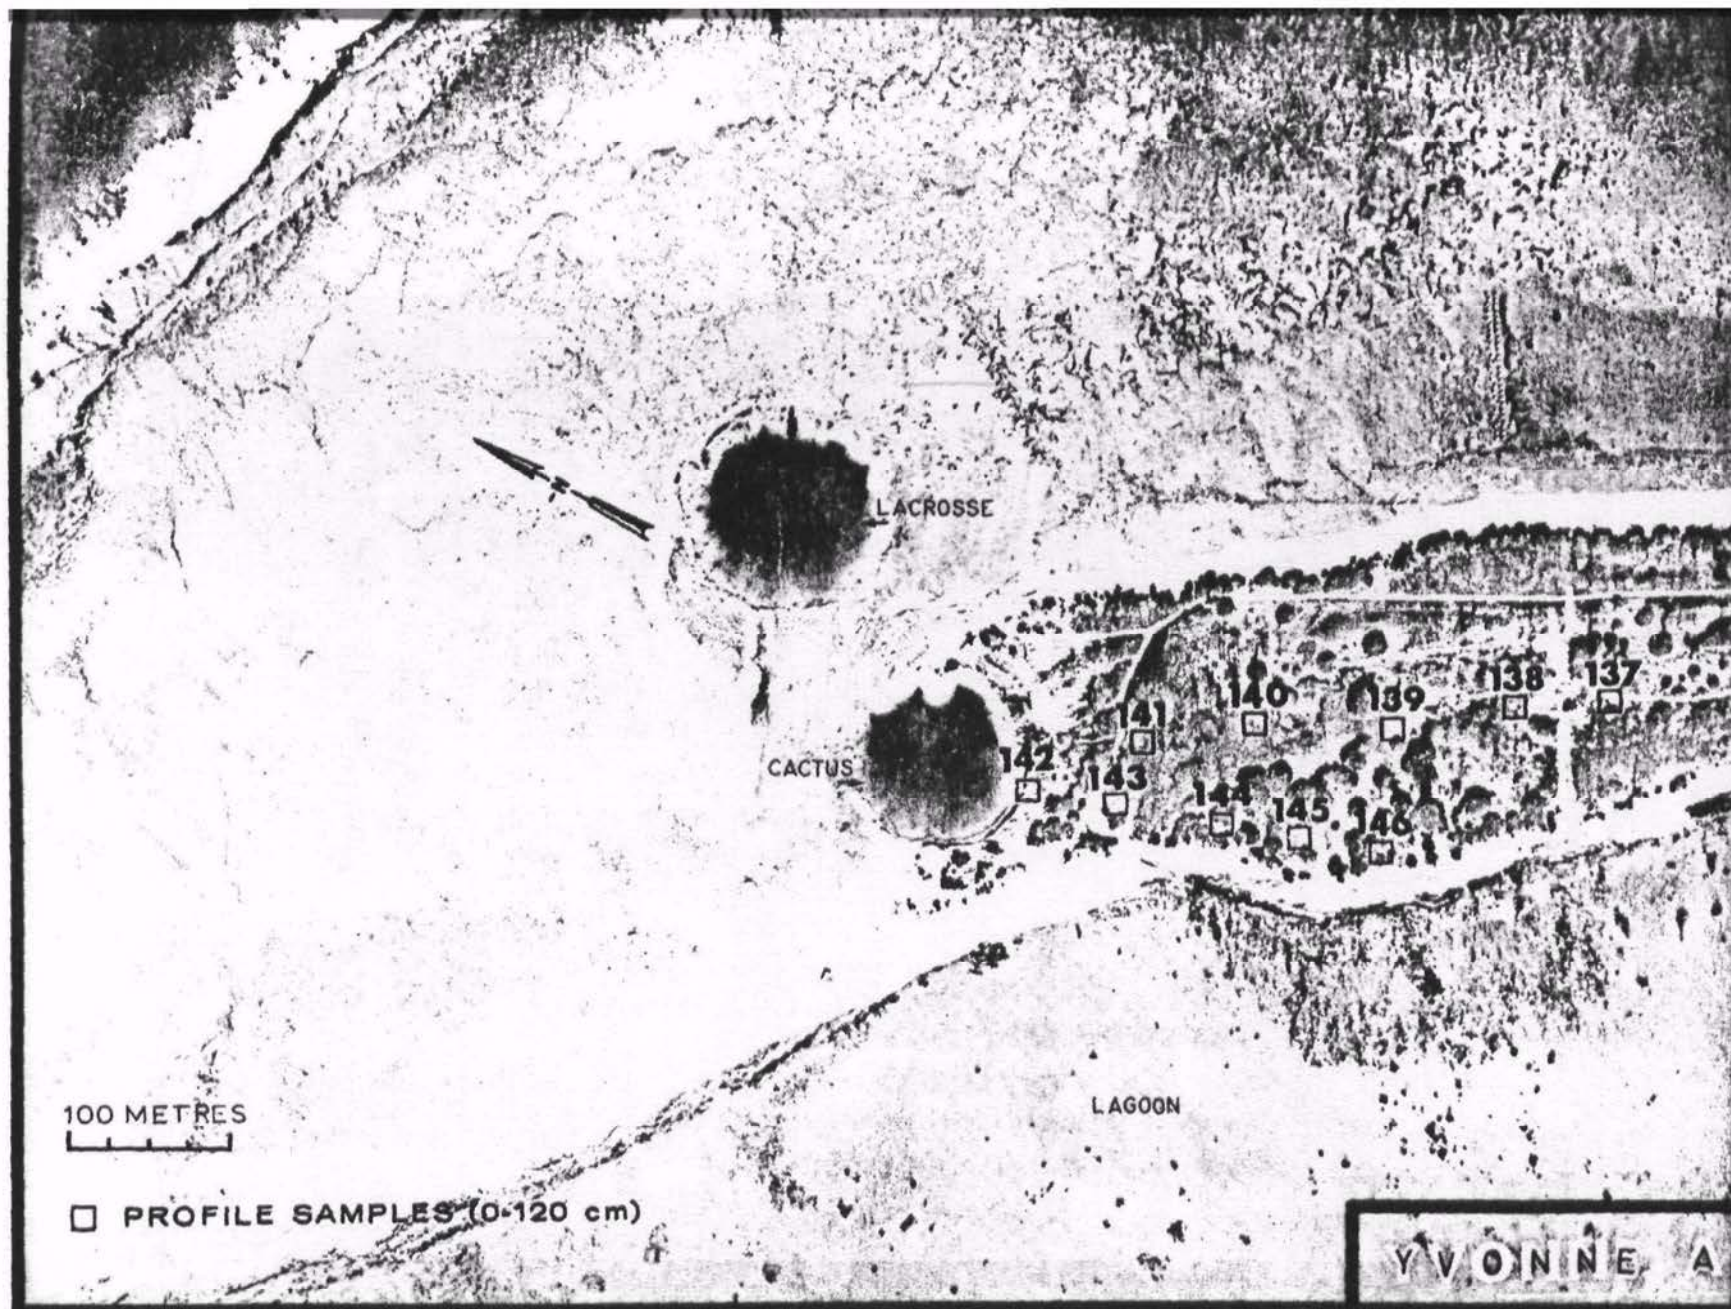
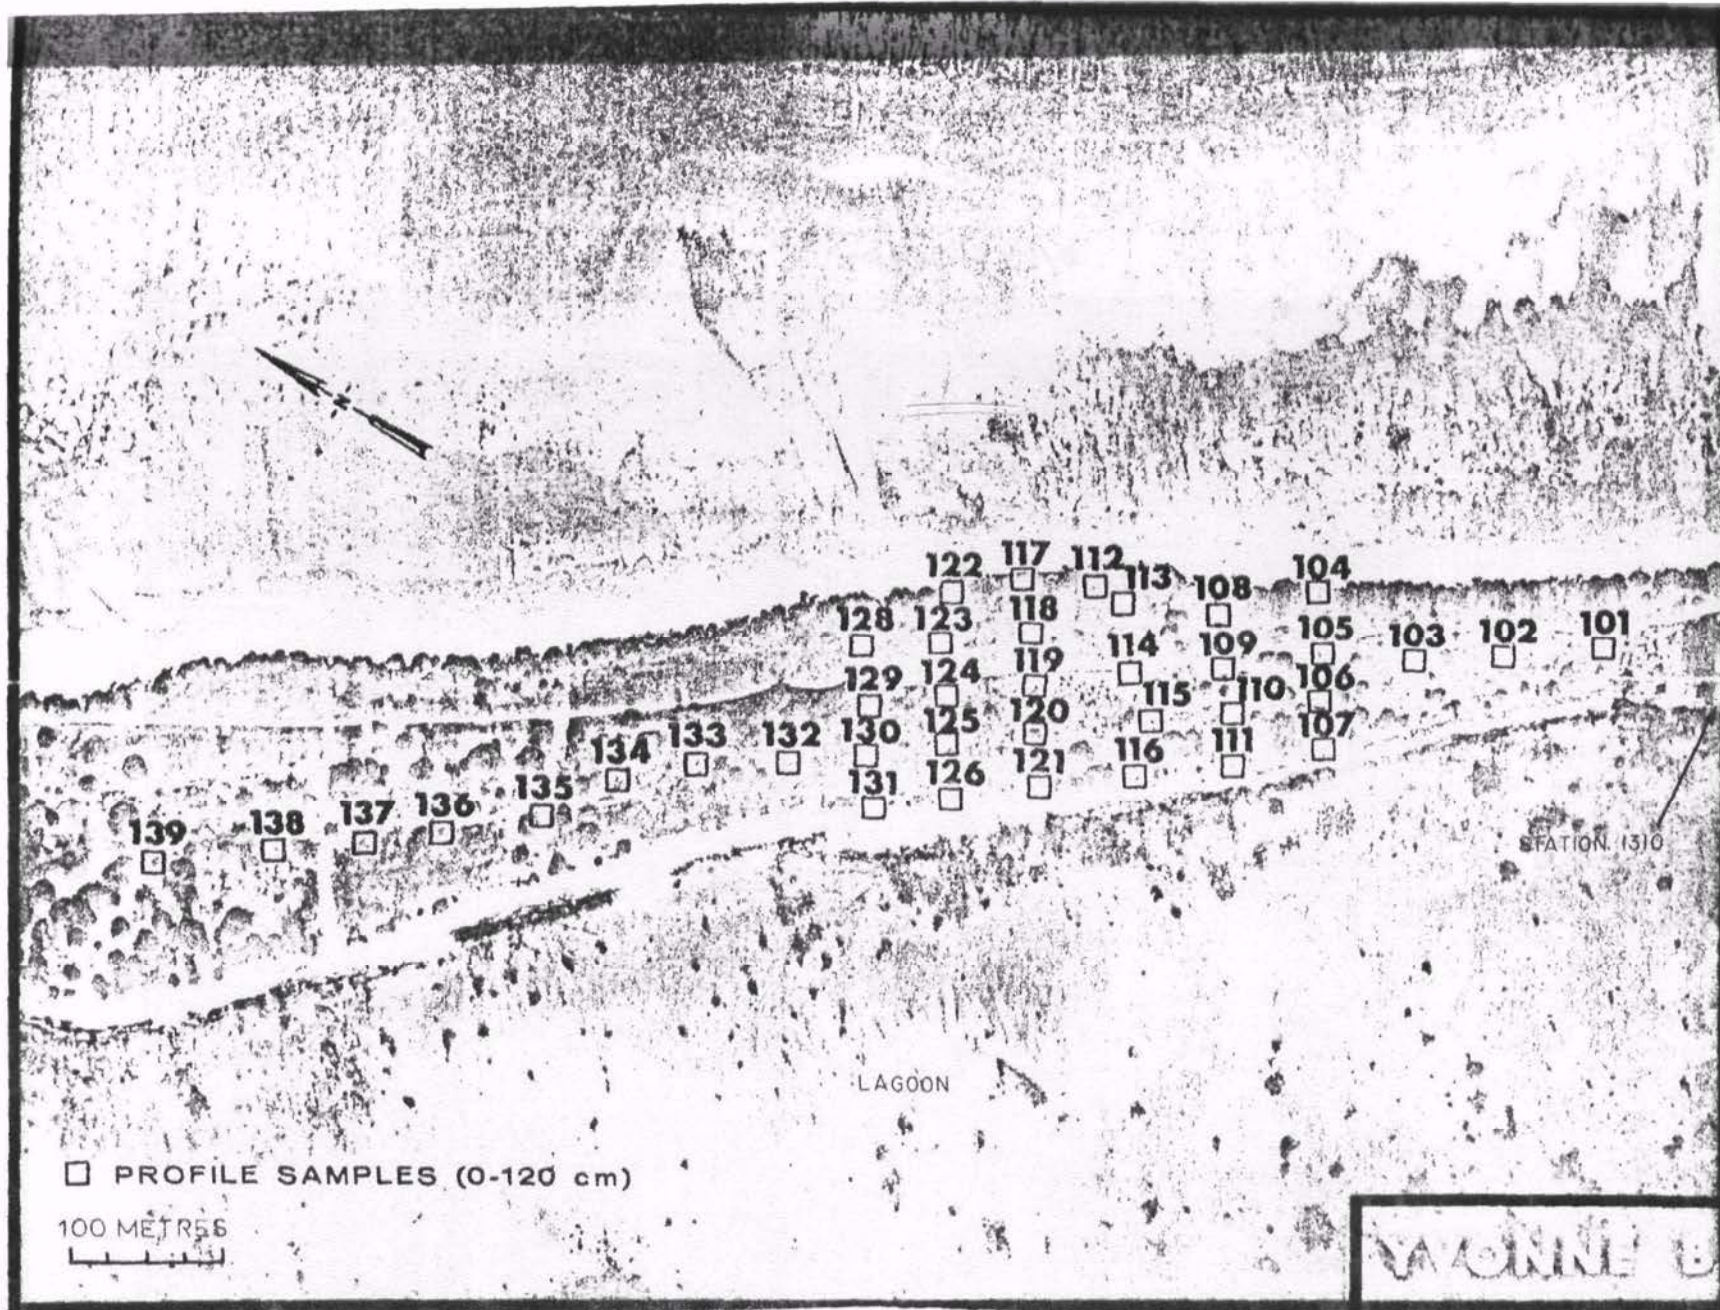
The soil sampling plan of the Enewetak Radiological Survey (NVO-140) is shown in Figures 71 and 79. The corresponding graphs present the radionuclide concentrations measured in the soil profile at each location. The plutonium profile data have been plotted in Figures 121-129, wherein the profiles represent a section either across the island or through a portion of its length with the locations presented in Figures 118-120. A significant portion of the activity is situated along the ocean side of the island between Locations 104 and 117. Within this area, the activities generally exceed 100 pCi/g to depths of 30 cm or more. These relatively high contamination levels appear to penetrate furthest inland along the Location 112 - 116 cross section, as evidenced by activity levels of greater than 100 pCi/g to depths of 50 cm at Location 113 and 10 cm at Location 114.

Elevated ^{239}Pu activities are also observed to a lesser extent along the lagoon side of the island. Activities exceeding 100 pCi/g were measured to depths of 20 cm within a narrow strip situated along Locations 111, 116, 120 and 125. An additional area of interest may be noted at depths of 60-90 cm beneath the surface within the island's interior. A strip, estimated to be as much as 100 - 200 feet wide, may be delineated at Location 110 and intersecting Locations 114 and 115. The ^{239}Pu activities generally exceed 10 pCi/g within the strip, with an observed maximum value of 70 pCi/g.

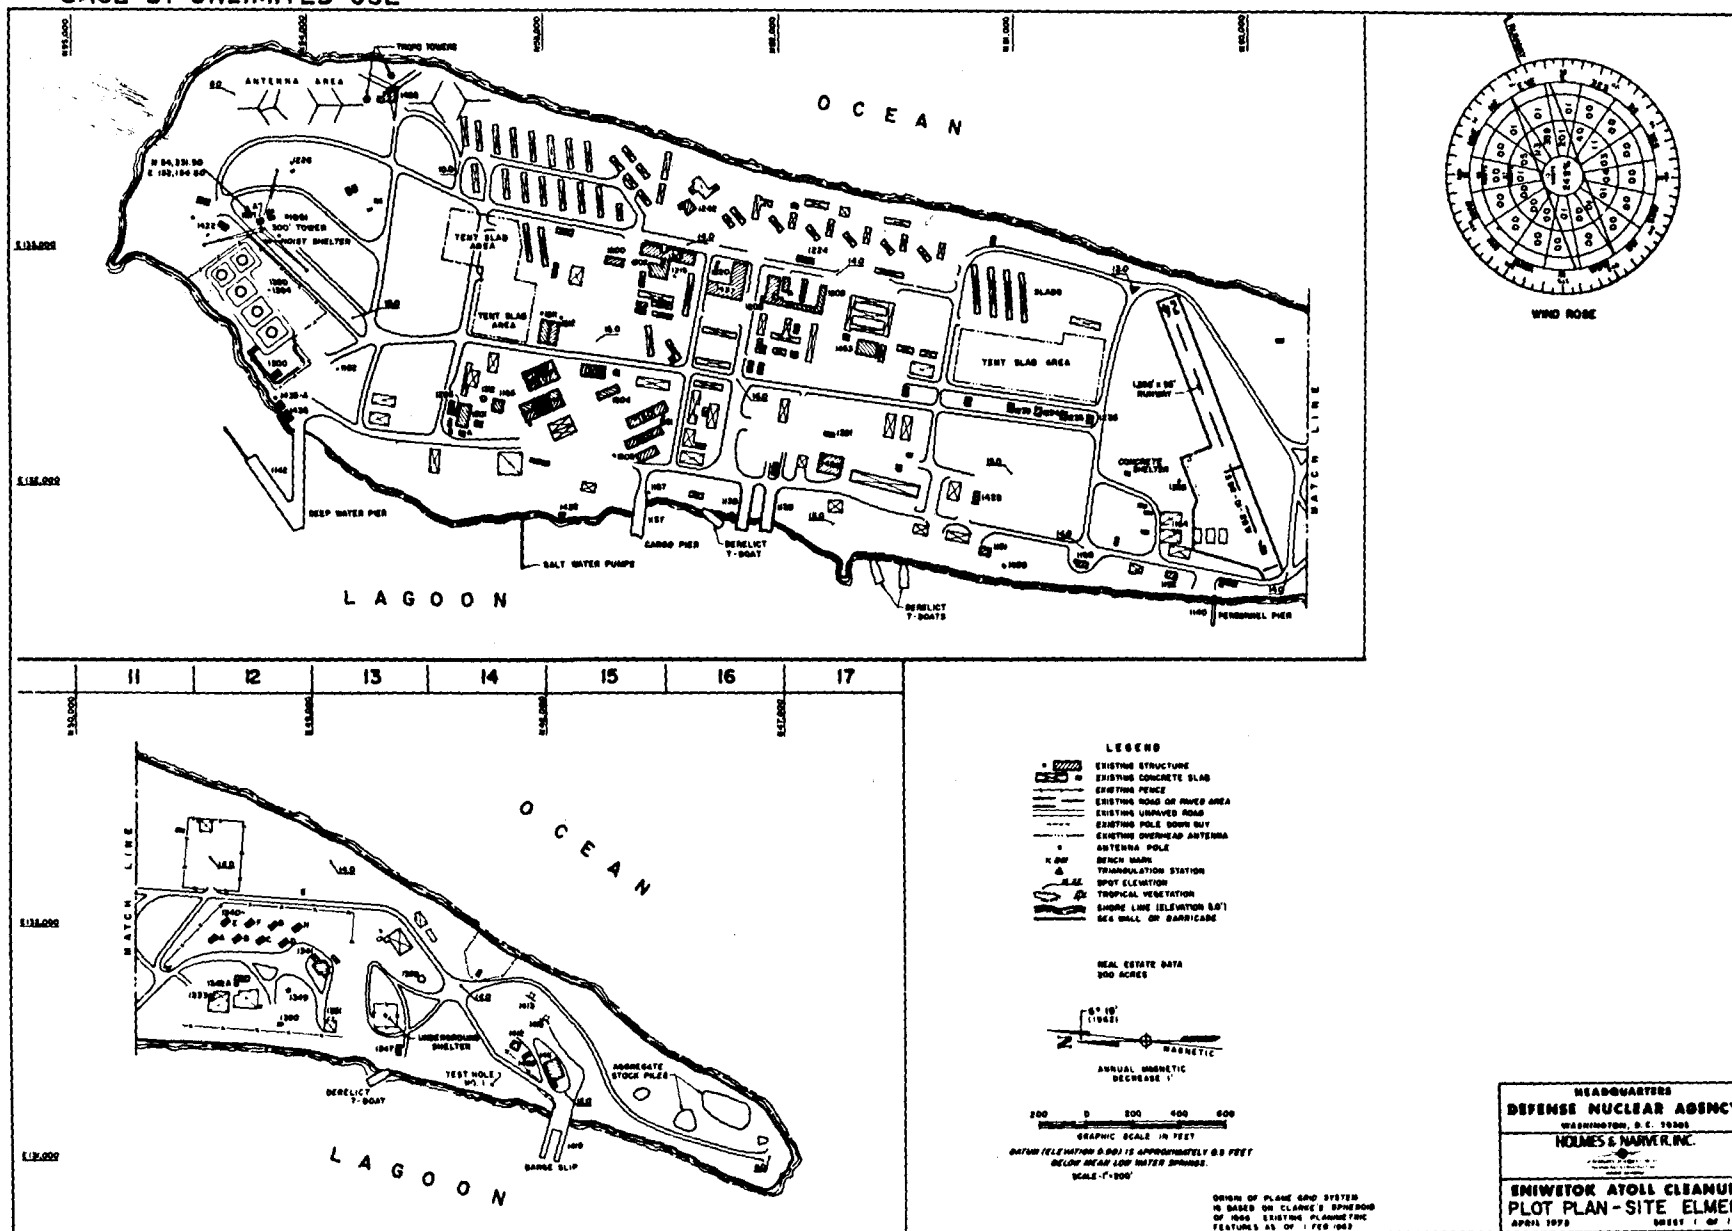
FIGURE 141. SITE ELMER, PLOT PLAN

ELMER was the support island used by the AEC and the scientific groups during the nuclear testing program. At its peak, it held facilities to house, feed and generally support up to 3000 people. Figure 141 is the Plot Plan of facilities at the end of testing. Some of the facilities have been removed, but many remain as indicated in the detail drawings in Figures 142-152. Almost half of the noncontaminated metal debris and concrete rubble on the Atoll is located on ELMER.

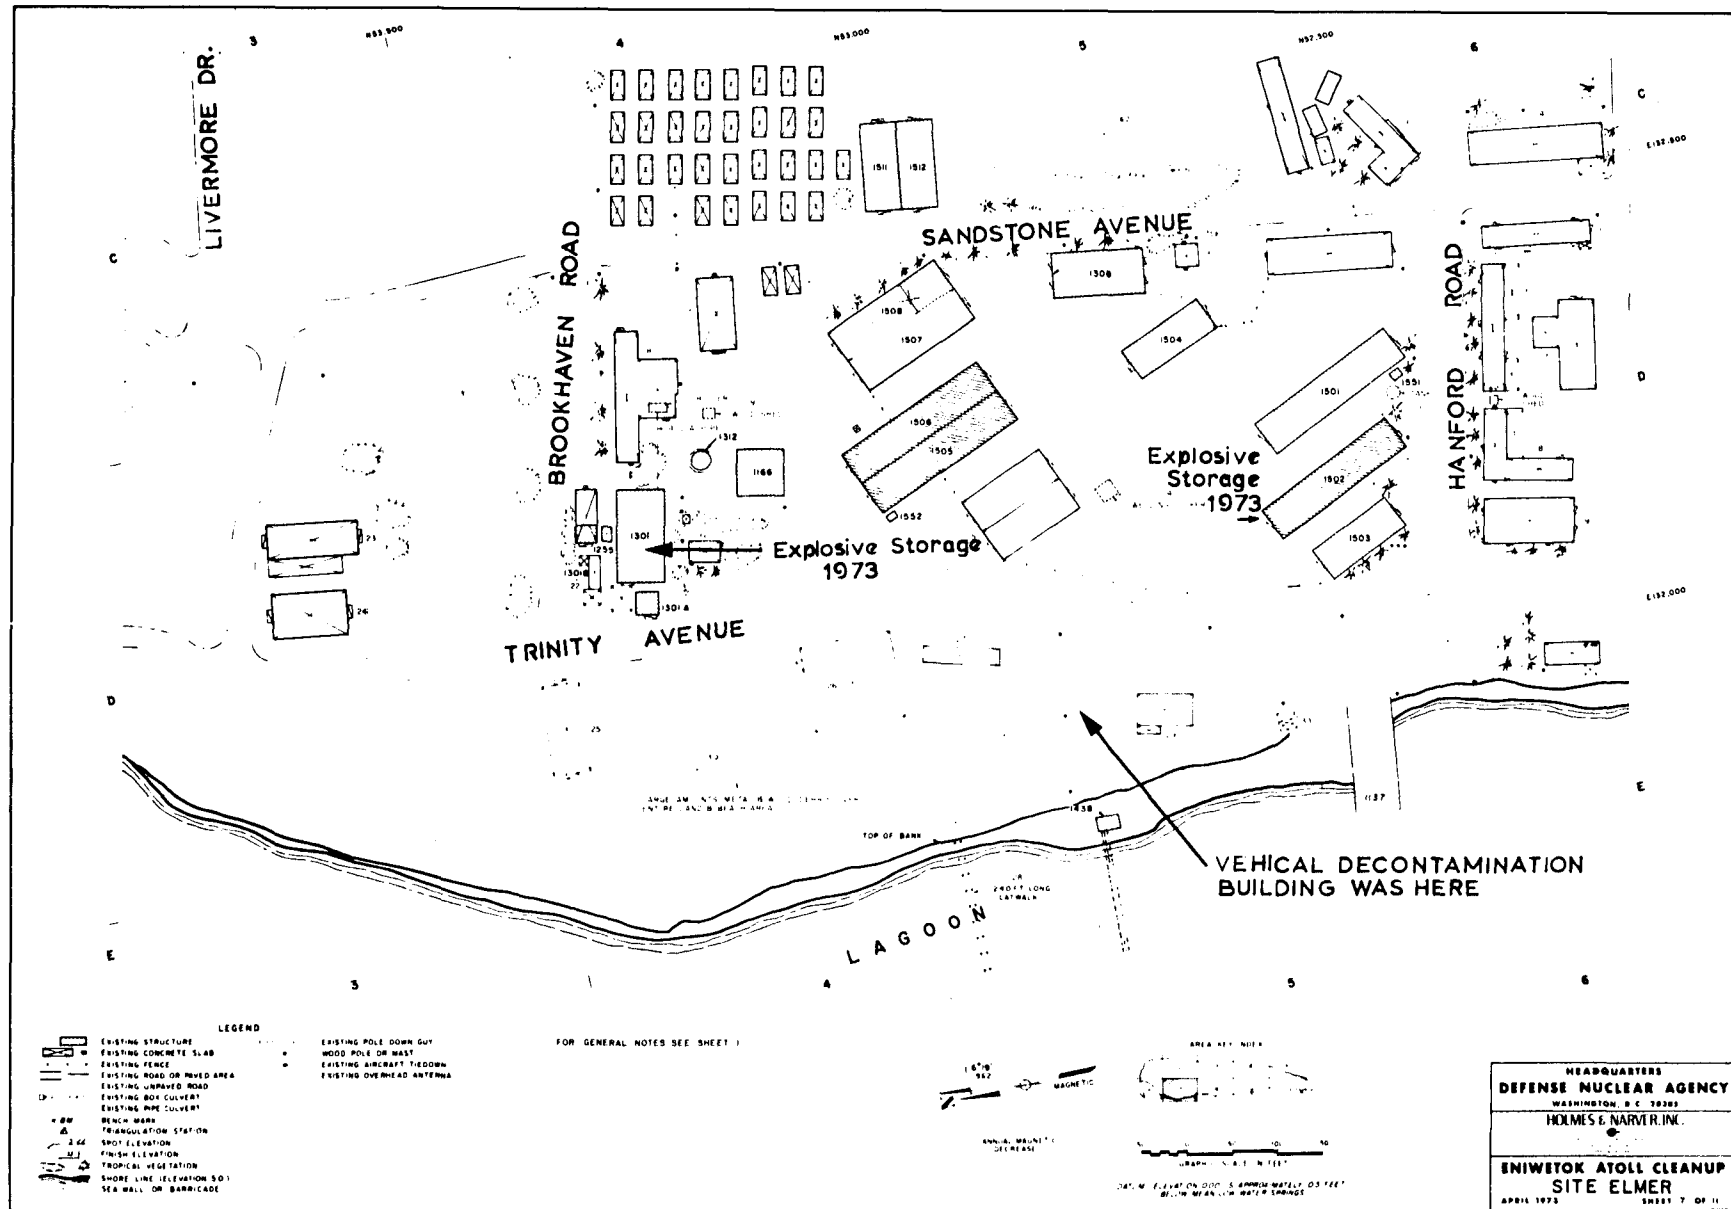
FIGURE 148. SITE ELMER, SHEET 7 OF 11

The higher values in this table were influenced by the decontamination area shown in Figure 145. This area was used for all manners of decontamination including heavy machinery and materials shipped from Bikini Atoll. During periods of high use, the ball field north of the decon pad was also used to store contaminated materials. The ball field was not extensively sampled according to NVO-140. The ball field as well as the decon area are shown on Figure 145. It has been verbally reported that some contaminated pipe exists in the decon area. Further, it would be advisable to check the drain outfall from this area for residual contamination. Various cleaning agents were used in the decontamination which may have suspended contamination for removal. These agents may have become ineffective when mixed with the seawater and resulted in a local concentration of contamination near the drain outfall. Similar examination of the facilities used for storage and decontamination for CASTLE and REDWING may be in order (see Figures 148 and 150).

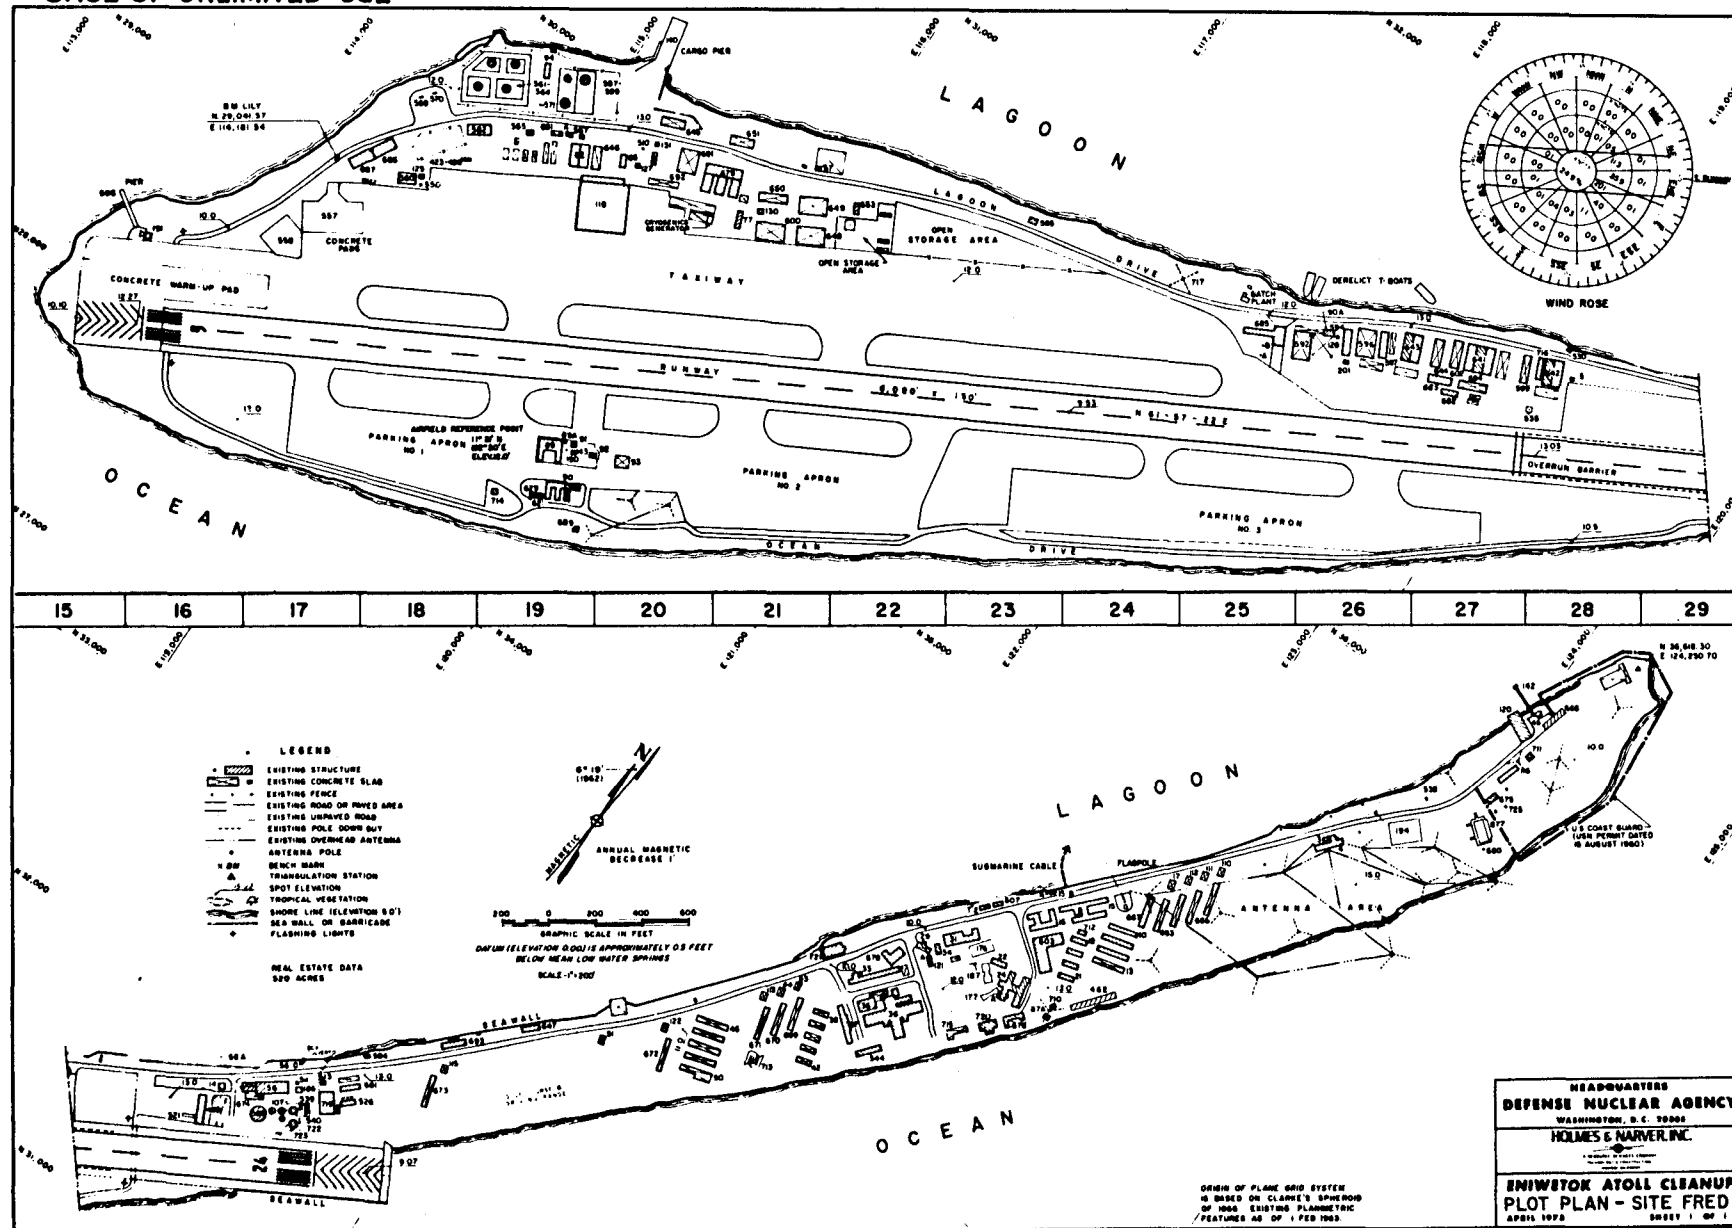
FIGURE 153. SITE FRED, PLOT PLAN

FRED is located in the southeast quadrant of Enewetak Atoll and has an area of about 322 acres (130 hectares). FRED is the largest island in the Atoll. It was the support base for the military segment of the nuclear test operations as well as support island for the Pacific Missile Range and the Air Force Western Test Range following nuclear testing. It has been selected as a residential island for the returning Enewetak people and will be the main support base for cleanup operations. Many structures are present on FRED, including an airport capable of handling large jet aircraft. Figure 153 is the Plot Plan of facilities at the end of testing. Details appear in Figures 154 through 171.
